Outdoor Condensation

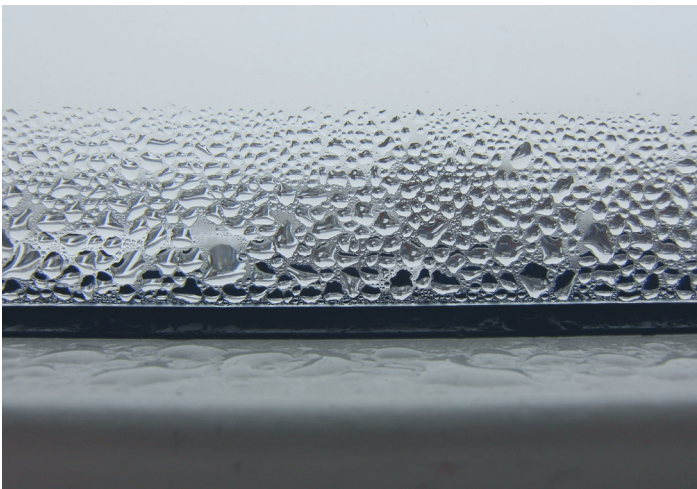
Although it may appear so, condensation on the outdoor surface of an insulating unit is not an indication of a defect. In fact, it is a natural process that occurs when the temperature of the glass falls below the dewpoint (which means the temperature that the air can no longer hold water).

Environmental factors that can cause condensation include:

- A clear night sky
- Still air
- High relative humidity
- Well-insulated glazings

Exposed to the above conditions, water will cool and moisture from the air will begin to collect on the surface of the glass.
